# **Intel<sup>®</sup> Pentium<sup>®</sup> II Xeon<sup>™</sup> Processor Specification Update**

Release Date: December 2000

Order Number: 243776-027

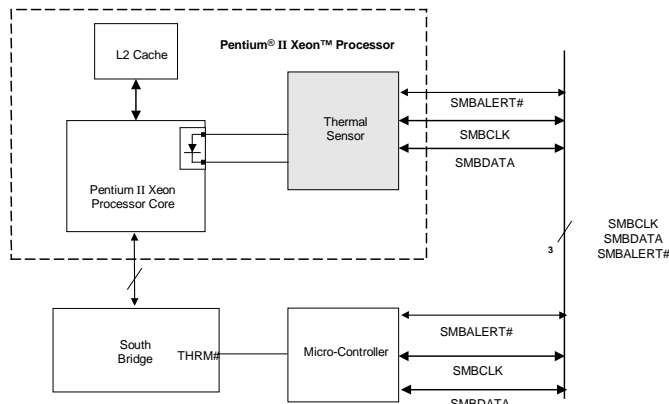
**Figure 1. An Example of Microcontroller Driven Thermal Management**

**Problem:** The Pentium II Xeon processor has a thermal sensor that monitors the processor core's temperature. The thermal sensor asserts SMBALERT# if the processor temperature exceeds the temperature limits set in the Alarm Threshold Registers ( $T_{HIGH}$ ,  $T_{LOW}$ ). It also sets the corresponding Status Register bits to identify the cause of the interrupt. Figure 1 gives one example of the how the SMBALERT# signal could be used in a system.

Under the conditions described below, the thermal sensor incorrectly generates the SMBALERT# interrupt. All of the following conditions must be met to trigger a false interrupt:

**Workaround:** Three different (mutually exclusive) workarounds are possible:
